RB711 workaround for loose MMCX pigtail connection

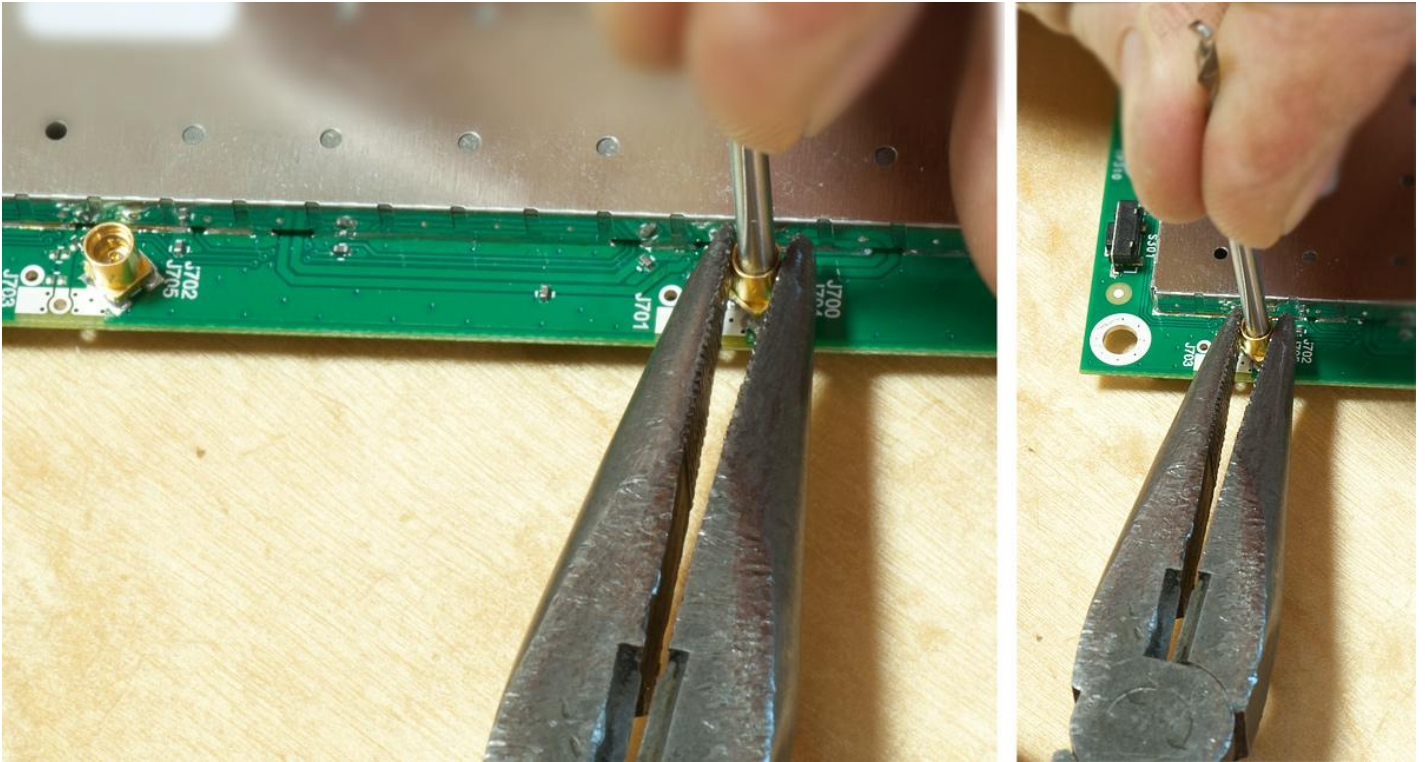
This instruction explains how to fix MMCX connectors on some RB711 devices which show signs of signal loss due to insufficient contact surface in the connector.

Insert the smooth end of a 2.8mm or 7/64" drill bit (or other round and similarly shaped exactly 2.8mm diameter object) into the connector, and squeeze the connector with standard round pliers. This will slightly deform the connector, making pigtail fit tightly. The connector is now ready to use.
